# **Evaluation of Pilot Deployment of Portable Visual Barriers to Reduce Rubbernecking Impact during Freeway Crashes**

**Project No. BED25-977-02**

## **Final Report**

**Prepared for  
Florida Department of Transportation**

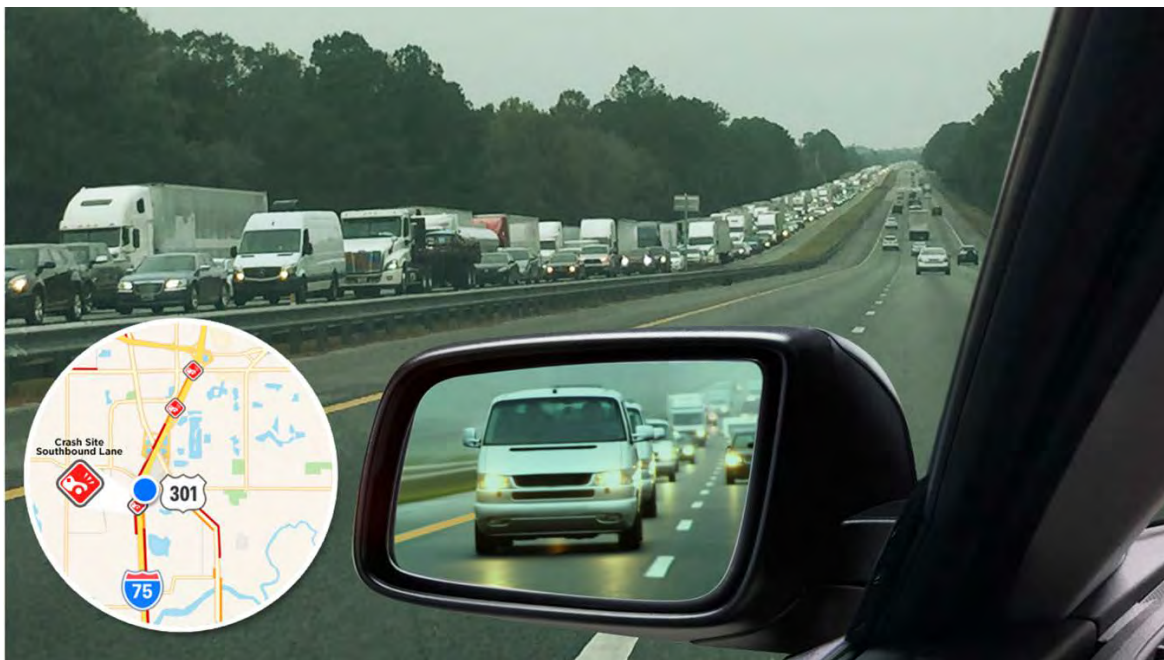
**Figure 1-1. Illustration of rubbernecking scenario**

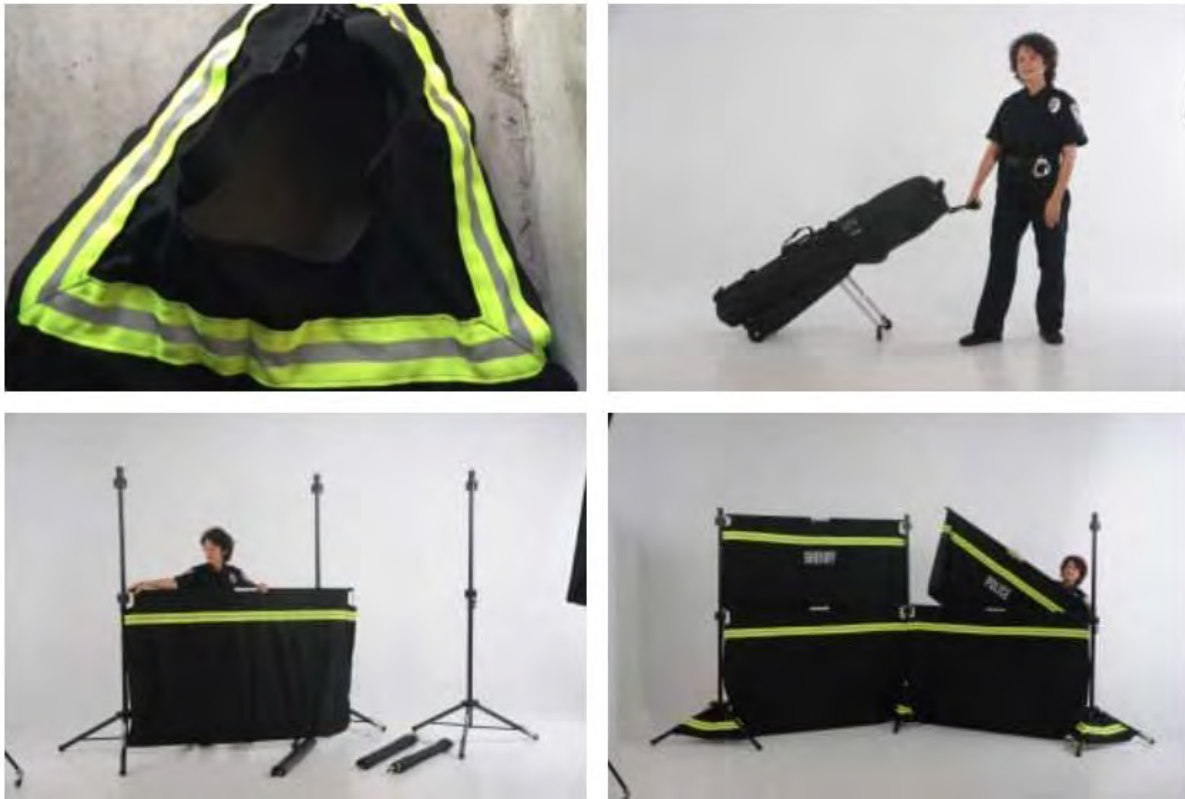
**Figure 2-4. SRN1000 example setup pictures**

- Each section of the barrier is 7 ft tall and 10 ft wide
- Weather-resistant that can support winds of 30 mph (strong magnets, bungee cords, 45 lbs of ballast weight bags of 15 lbs per tripod, steel ground spikes help hold system down in winds up to 30 mph)
- Each system includes two sections, three steel tripods and four convertible heavy-duty fabric (nylon) screens (foldable metal tripod stands)
- Easy to carry and set up
- Available in a portable bag (wheeled carrying case about the size of a typical golf bag)
- Retail price of \$1,263.42 – \$3,406.41
- They weigh about 50 lbs
- Extensions can be added to make the barrier longer
- Can be set up by a single person with no tools in less than five minutes, and can fit into any truck or inside a vehicle
- Customizable and can include the logo of law enforcement organizations

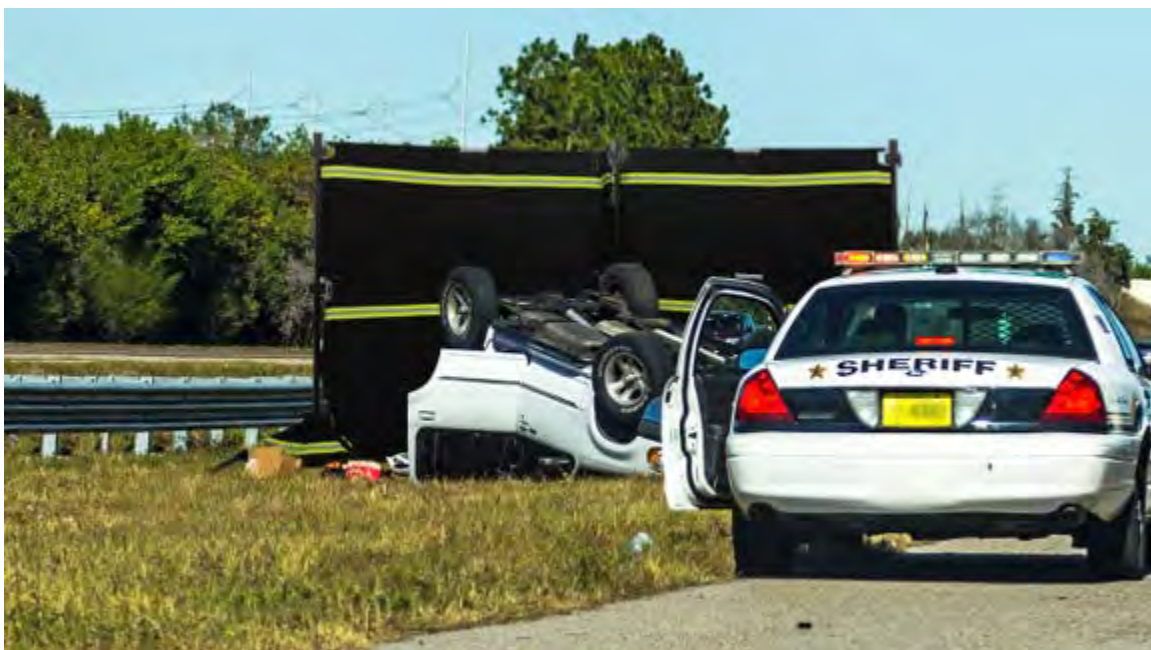
**Figure 2-5. Rendering of the PVB used during a crash**

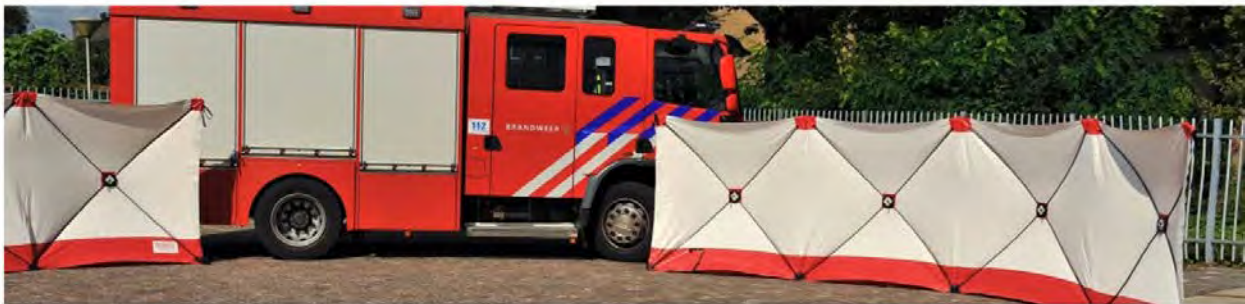
**Figure 2-10. Portable privacy screen used in the Netherlands**

One person can easily set up the screen within minutes and can be folded to take up little space. The barrier can be arranged into various formations, and multiple screens can be linked through straps attached on both sides of the screen. The barrier can support mild wind conditions without extra aids and can be anchored to the ground using tent pegs and guy lines in windy and uneven conditions.

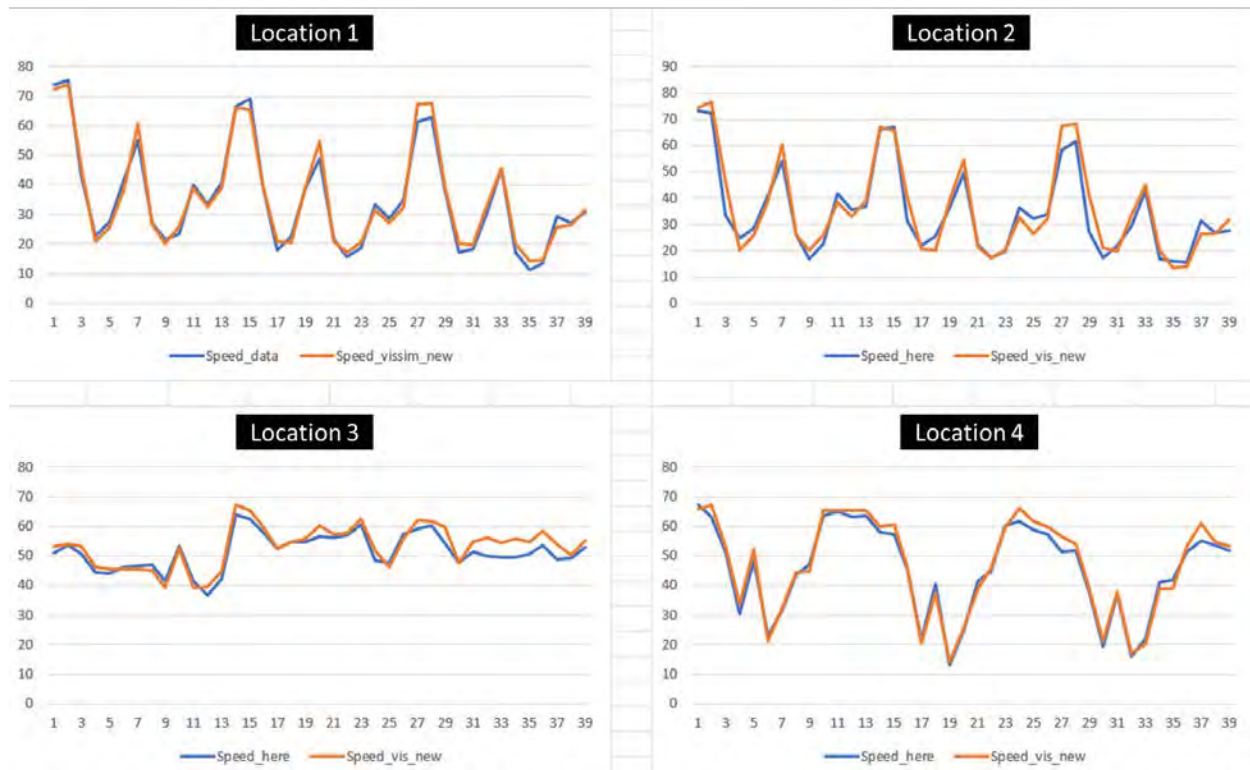
**Figure 4-5 Calibration Results for VISSIM Roadway Geometry**

The simulation model was estimated to depict the real-world scenarios and match the data collected. To calibrate the model, the speeds and volumes from RITIS in a real-world rubbernecking case due to a freeway crash were included in the traffic simulation. Then the speeds from the real-world and simulated environment were compared, and the simulation model was adjusted so that these performance metrics matched. There were 4 locations in the simulation roadway geometry where the speeds were matched to make sure the simulation was realistic throughout the network. The results of the calibration are shown in Figure 4-5. As seen in the figure, the speeds from the real world and the simulation match and hence it is safe to assume that the simulation model is calibrated.

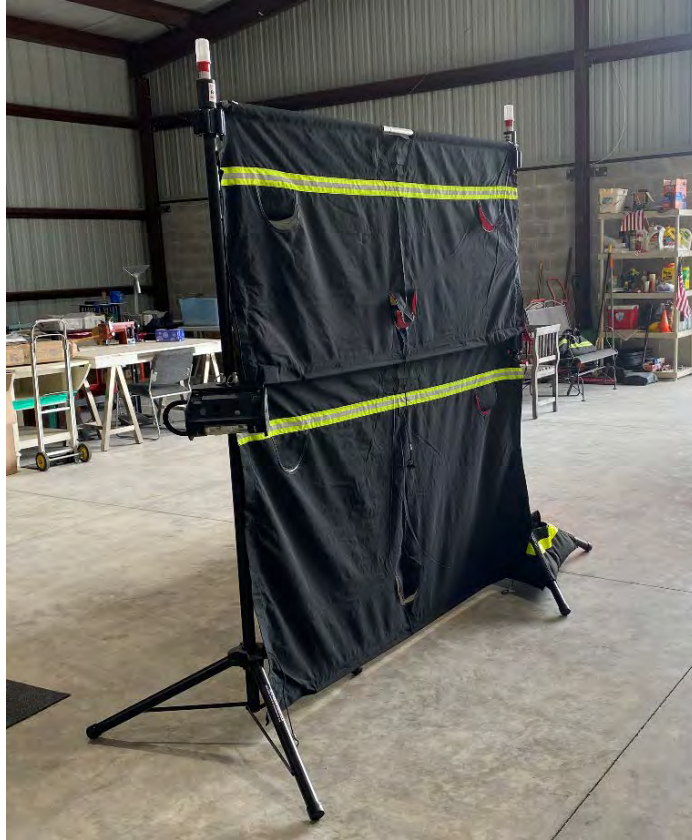
**Figure 5-1. SRN1000 screen**

The project team contacted those companies to acquire more information about their PVB products. The team visited the local company in October 2022 for a showcase and to speak with its president and CEO. The barrier is a two-section 6-feet wide and 6-feet tall screen that uses two tripods for setup (Figure 5-1). The team also spoke with the president of the second company in North Carolina (NC) to acquire information about their system. It is a similar design with two tripods and one screen section that is 10 feet wide and 6 feet tall (Figure 5-2).

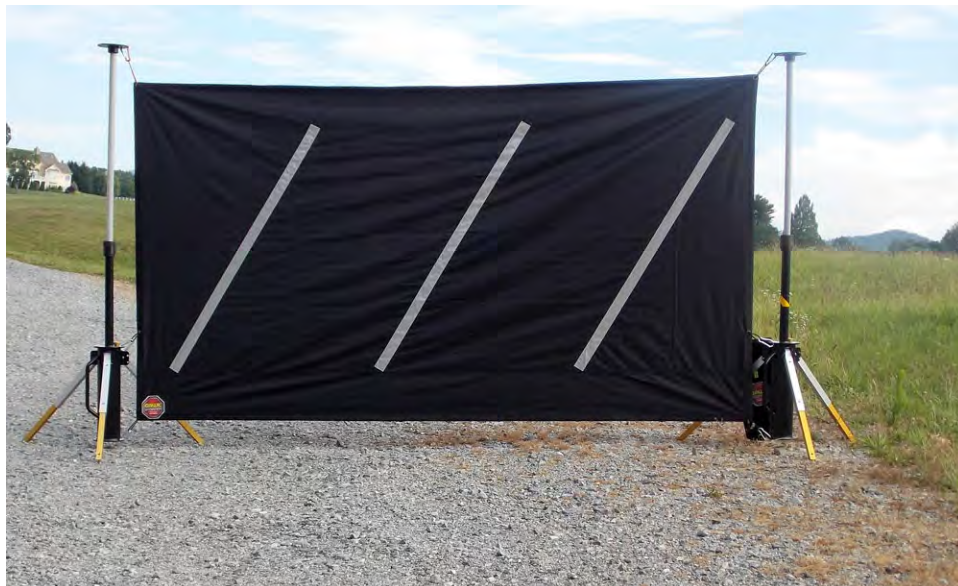
**Figure 5-2. GawKStopper screen**

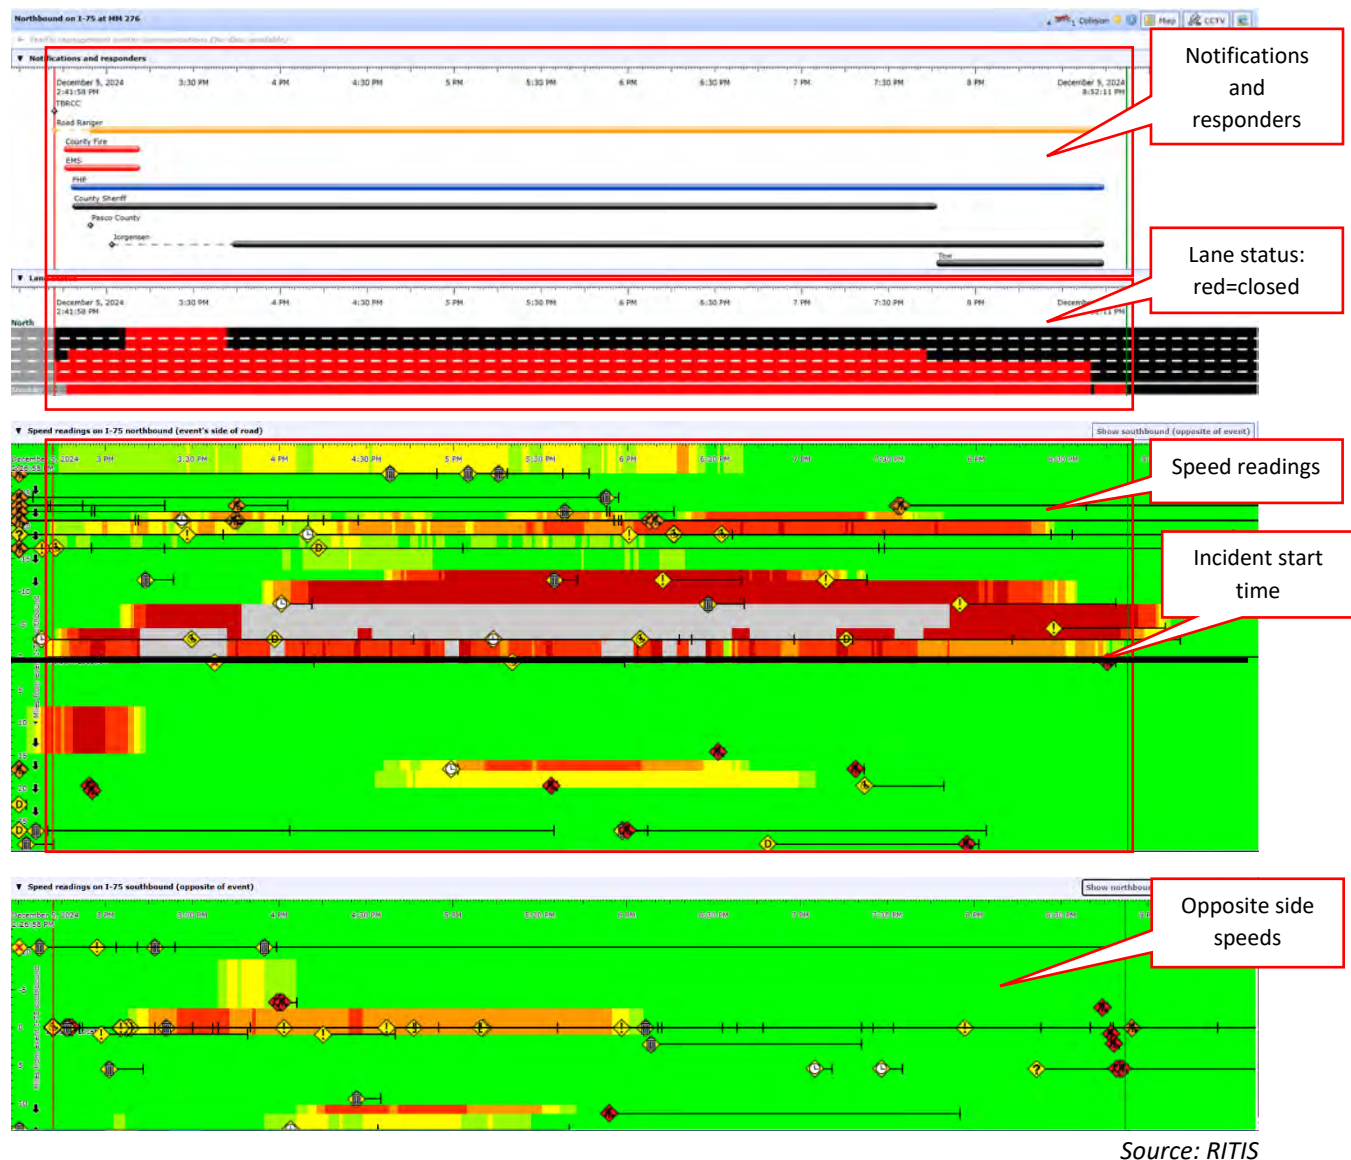
**Figure 5-17. Timeline of a fatal motorcycle crash on I-75 NB with PVB deployment**

The incident timeline is shown in Figure 5-17. The first part of the figure presents notifications and responders along with the amount of time each spent at the scene. The second part of the figure shows the number of lanes and which ones were blocked. For example, in this incident, all lanes were closed for 34 minutes, and then the two inside lanes were opened to traffic. The third part shows the speed profile of the vehicles traveling on the side of the crash. The x-axis shows time, and the y-axis shows distance in miles. The location of the incident is shown, along with the congestion that followed. The fourth part of the figure shows the speed profile of vehicles traveling in the opposite direction. This is the side of the road where rubbernecking occurs. As shown in the figure, there is congestion at the same location as the incident, but it does not extend as far back as on the side of the crash.

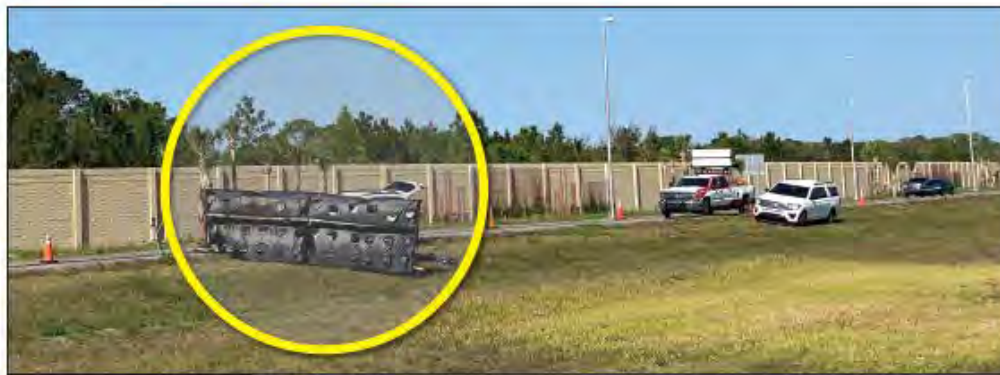
Figure 2 - Deployed PVB
